# SERVICE BULLETIN

SB No. **L-410/005b**

Aeroplane Type: **L-410**

**Subject:** Inspection and possible replacement of the bracket in the power steering of the nose landing gear.

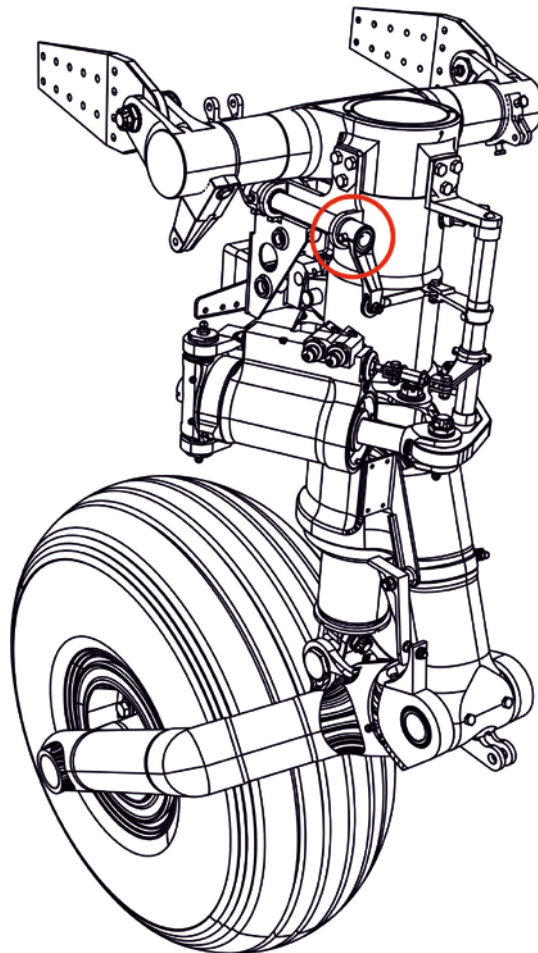
Crack in the bracket 3 245 092 0 (2 123 092).

Using a 6x magnifying glass, check for cracks in the nose thruster power steering bracket type no. 3 245 092 0 (order no. 2 123 092) pos. 92 on the drawing of the nose landing gear in Annex 1, in the area as show in the figure below. Cracks on the bracket are not permitted.

If cracks are found on the bracket, replace the bracket according to section 2.B. of this bulletin.
