Aircraft Industries

MANDATORY BULLETIN

SB No.: L-420/021a Revision 2

Subject: Nose landing gear inspection and eventually replacement of the L3 223 016 pin with the new L3 223 316 pin of the lever assembly of the nose landing gear steering. Prescription the torque for installation of the retaining bolt.

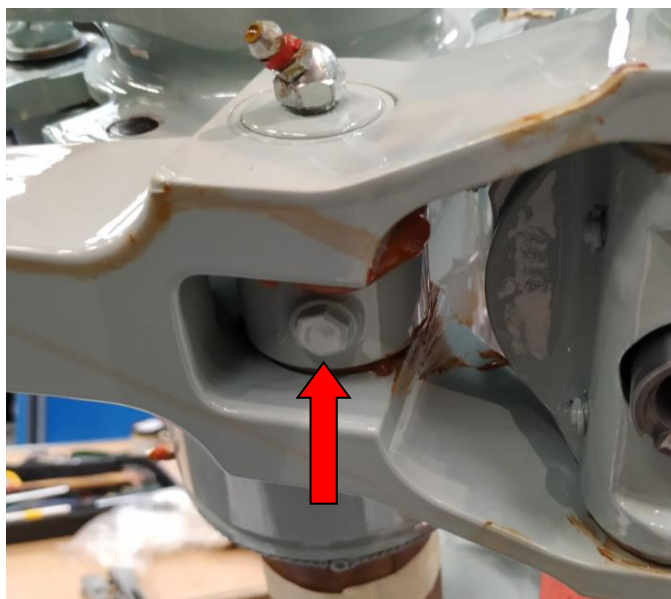
Figure 1 - L3 223 016 pin without head secured with a retaining bolt

If the L3 223 016 pin without head and secured with retaining bolt is installed (refer to the Figure 1), perform the L3 223 016 pin replacement according the point 2.B., C. of this bulletin.

- Remove the grease nipples.
- Heat the retaining bolt secured with Loctite 270 adhesive on the lever assembly see Figure 1 to 250°C with a hot air gun.
- Unscrew the retaining bolt.
- Remove the original pin pos. 16.

- Check the surface of the sliding bushes.
- Install the new pin pos. 16, put on washer pos. 142 and secure it with lock ring pos. 143 according to the Dwg. No. 2 143 900. Use material of point 3.A. of this bulletin
- Degrease the threads of the retaining bolt pos. 106 and pin pos. 16.
- Apply Loctite 270 on the retaining bolt thread, according to the technical sheet. Screw on the retaining bolt to the pin and tighten it, use torque 8 Nm!
- Install back the grease nipples.

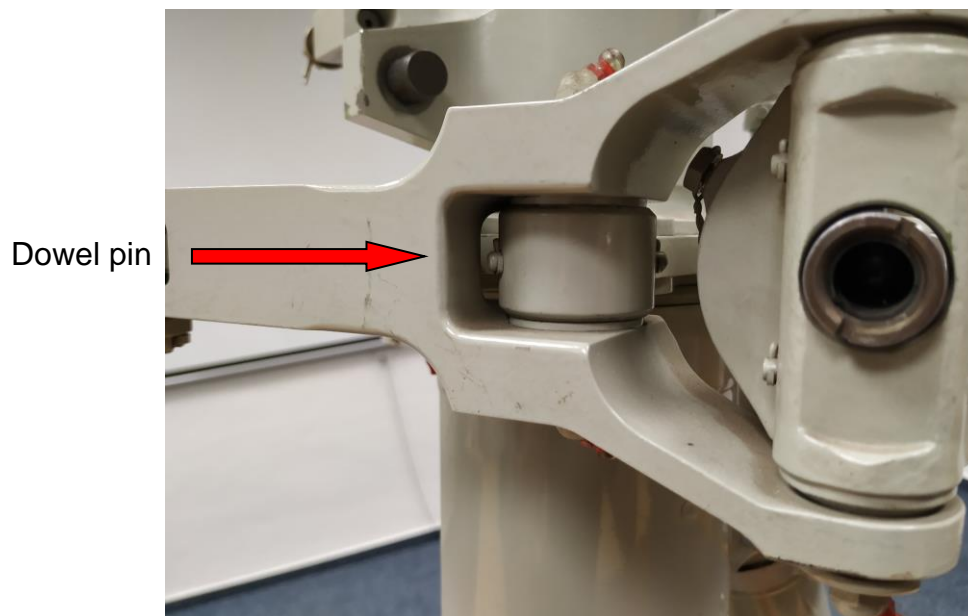
Figure 2 - L3 245 016 pin without head secured with a dowel pin

If the L3 245 016 pin without head and secured with dowel pin is installed (refer to the Figure 2) record the inspection of the nose landing gear into the log book according to the point 4.b) of this bulletin.
