# SERVICE BULLETIN

SB No. **L-410/059b**

Aeroplane Type: **L-410**

**Subject:** Installation of a washer under bolt head of the elevator hinges.

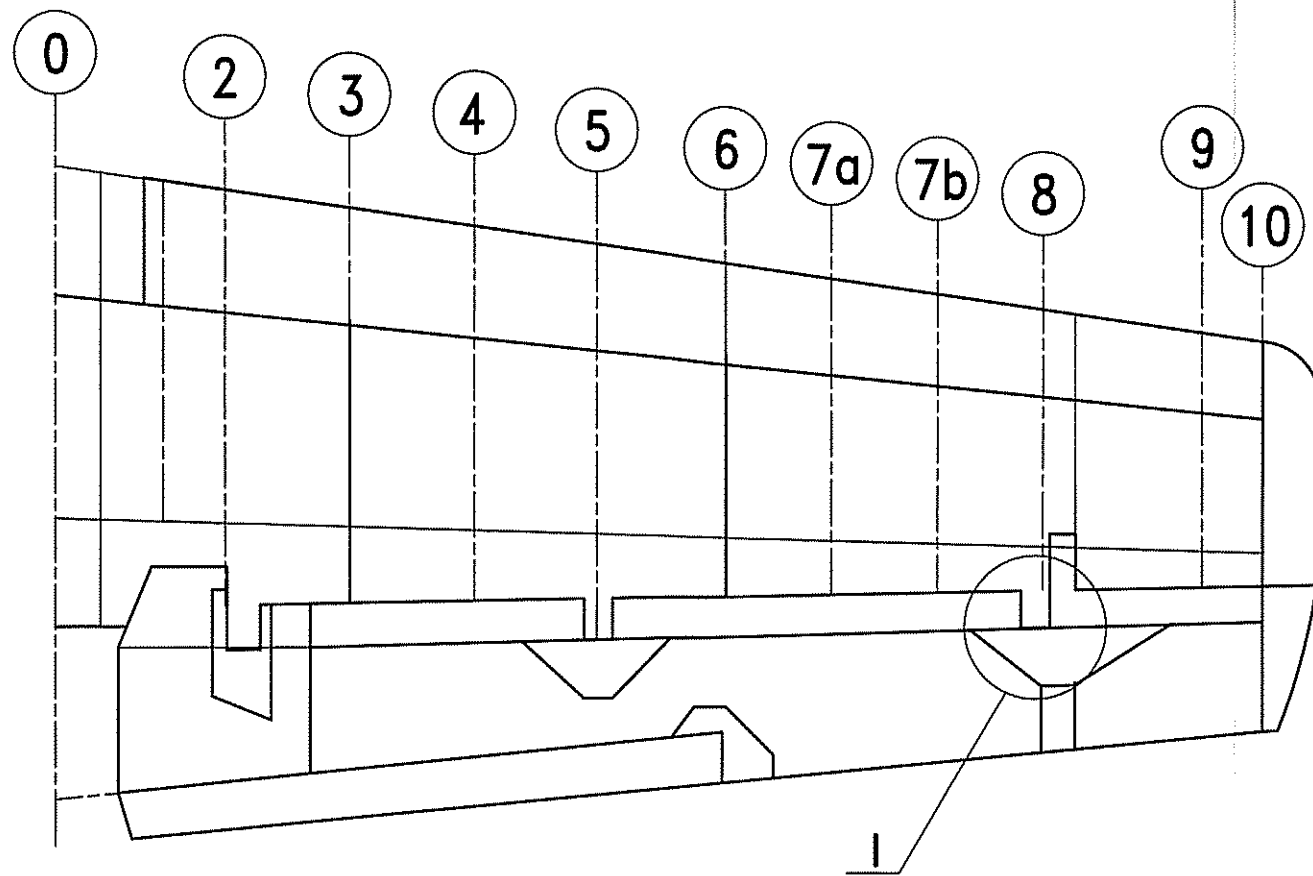
# Detail I<sub>2</sub>

A lug of the elevator hinge has been abraded from the bolt head.

- Remove the split pin pos. 41, unscrew nut pos. 33 and remove washer pos. 37 and bolt pos. 27, Dwg No. B530 200N sheet 2, Detail I2. Keep the dust catchers in the hinge.
