Aircraft Industries

MANDATORY BULLETIN

SB No.: L410UVP-E/144a Revision 2

Nose landing gear inspection and eventually replacement of the L3 223 016 pin with the new L3 223 316 pin of the lever assembly of the nose landing gear steering. Prescription the torque for installation of the retaining bolt.

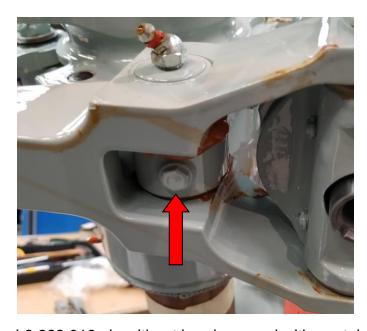
Using of modified pin to prevent falling out from the nose landing gear steering. Malfunction of the steering on the nose landing gear was reported by L-410 operators. Investigation determined that the malfunction was due to loss of the vertical pin further to a cracking of the retaining bolt on the nose landing gear control.

Figure 1 - L3 223 016 pin without head secured with a retaining bolt

If the L3 223 016 pin without head and secured with retaining bolt is installed (refer to the Figure 1), perform the L3 223 016 pin replacement according the point 2.B., C. of this bulletin.

- Remove the grease nipples.
- Heat the retaining bolt secured with Loctite 270 adhesive on the lever assembly see Figure 1 to 250°C with a hot air gun.
- Unscrew the retaining bolt.
- Remove the original pin pos. 16.

- Check the surface of the sliding bushes.
- Install the new pin pos. 16, put on washer pos. 142 and secure it with lock ring pos. 143 according to the Dwg. No. 2 143 900. Use material of point 3.A. of this bulletin
- Degrease the threads of the retaining bolt pos. 106 and pin pos. 16.
- Apply Loctite 270 on the retaining bolt thread, according to the technical sheet. Screw on the retaining bolt to the pin and tighten it, use torque 8 Nm!
- Install back the grease nipples.

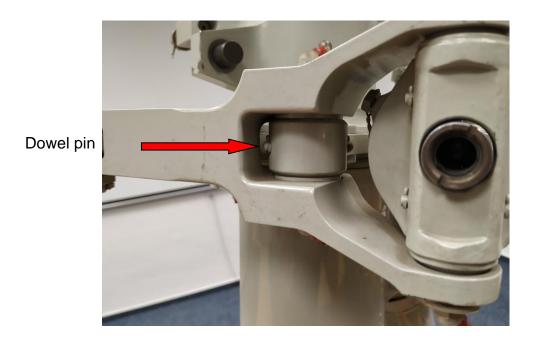
Figure 2 - L3 245 016 pin without head secured with a dowel pin

If the L3 245 016 pin without head and secured with dowel pin is installed (refer to the Figure 2), record the inspection of the nose landing gear into the log book according to the point 4.b) of this bulletin.

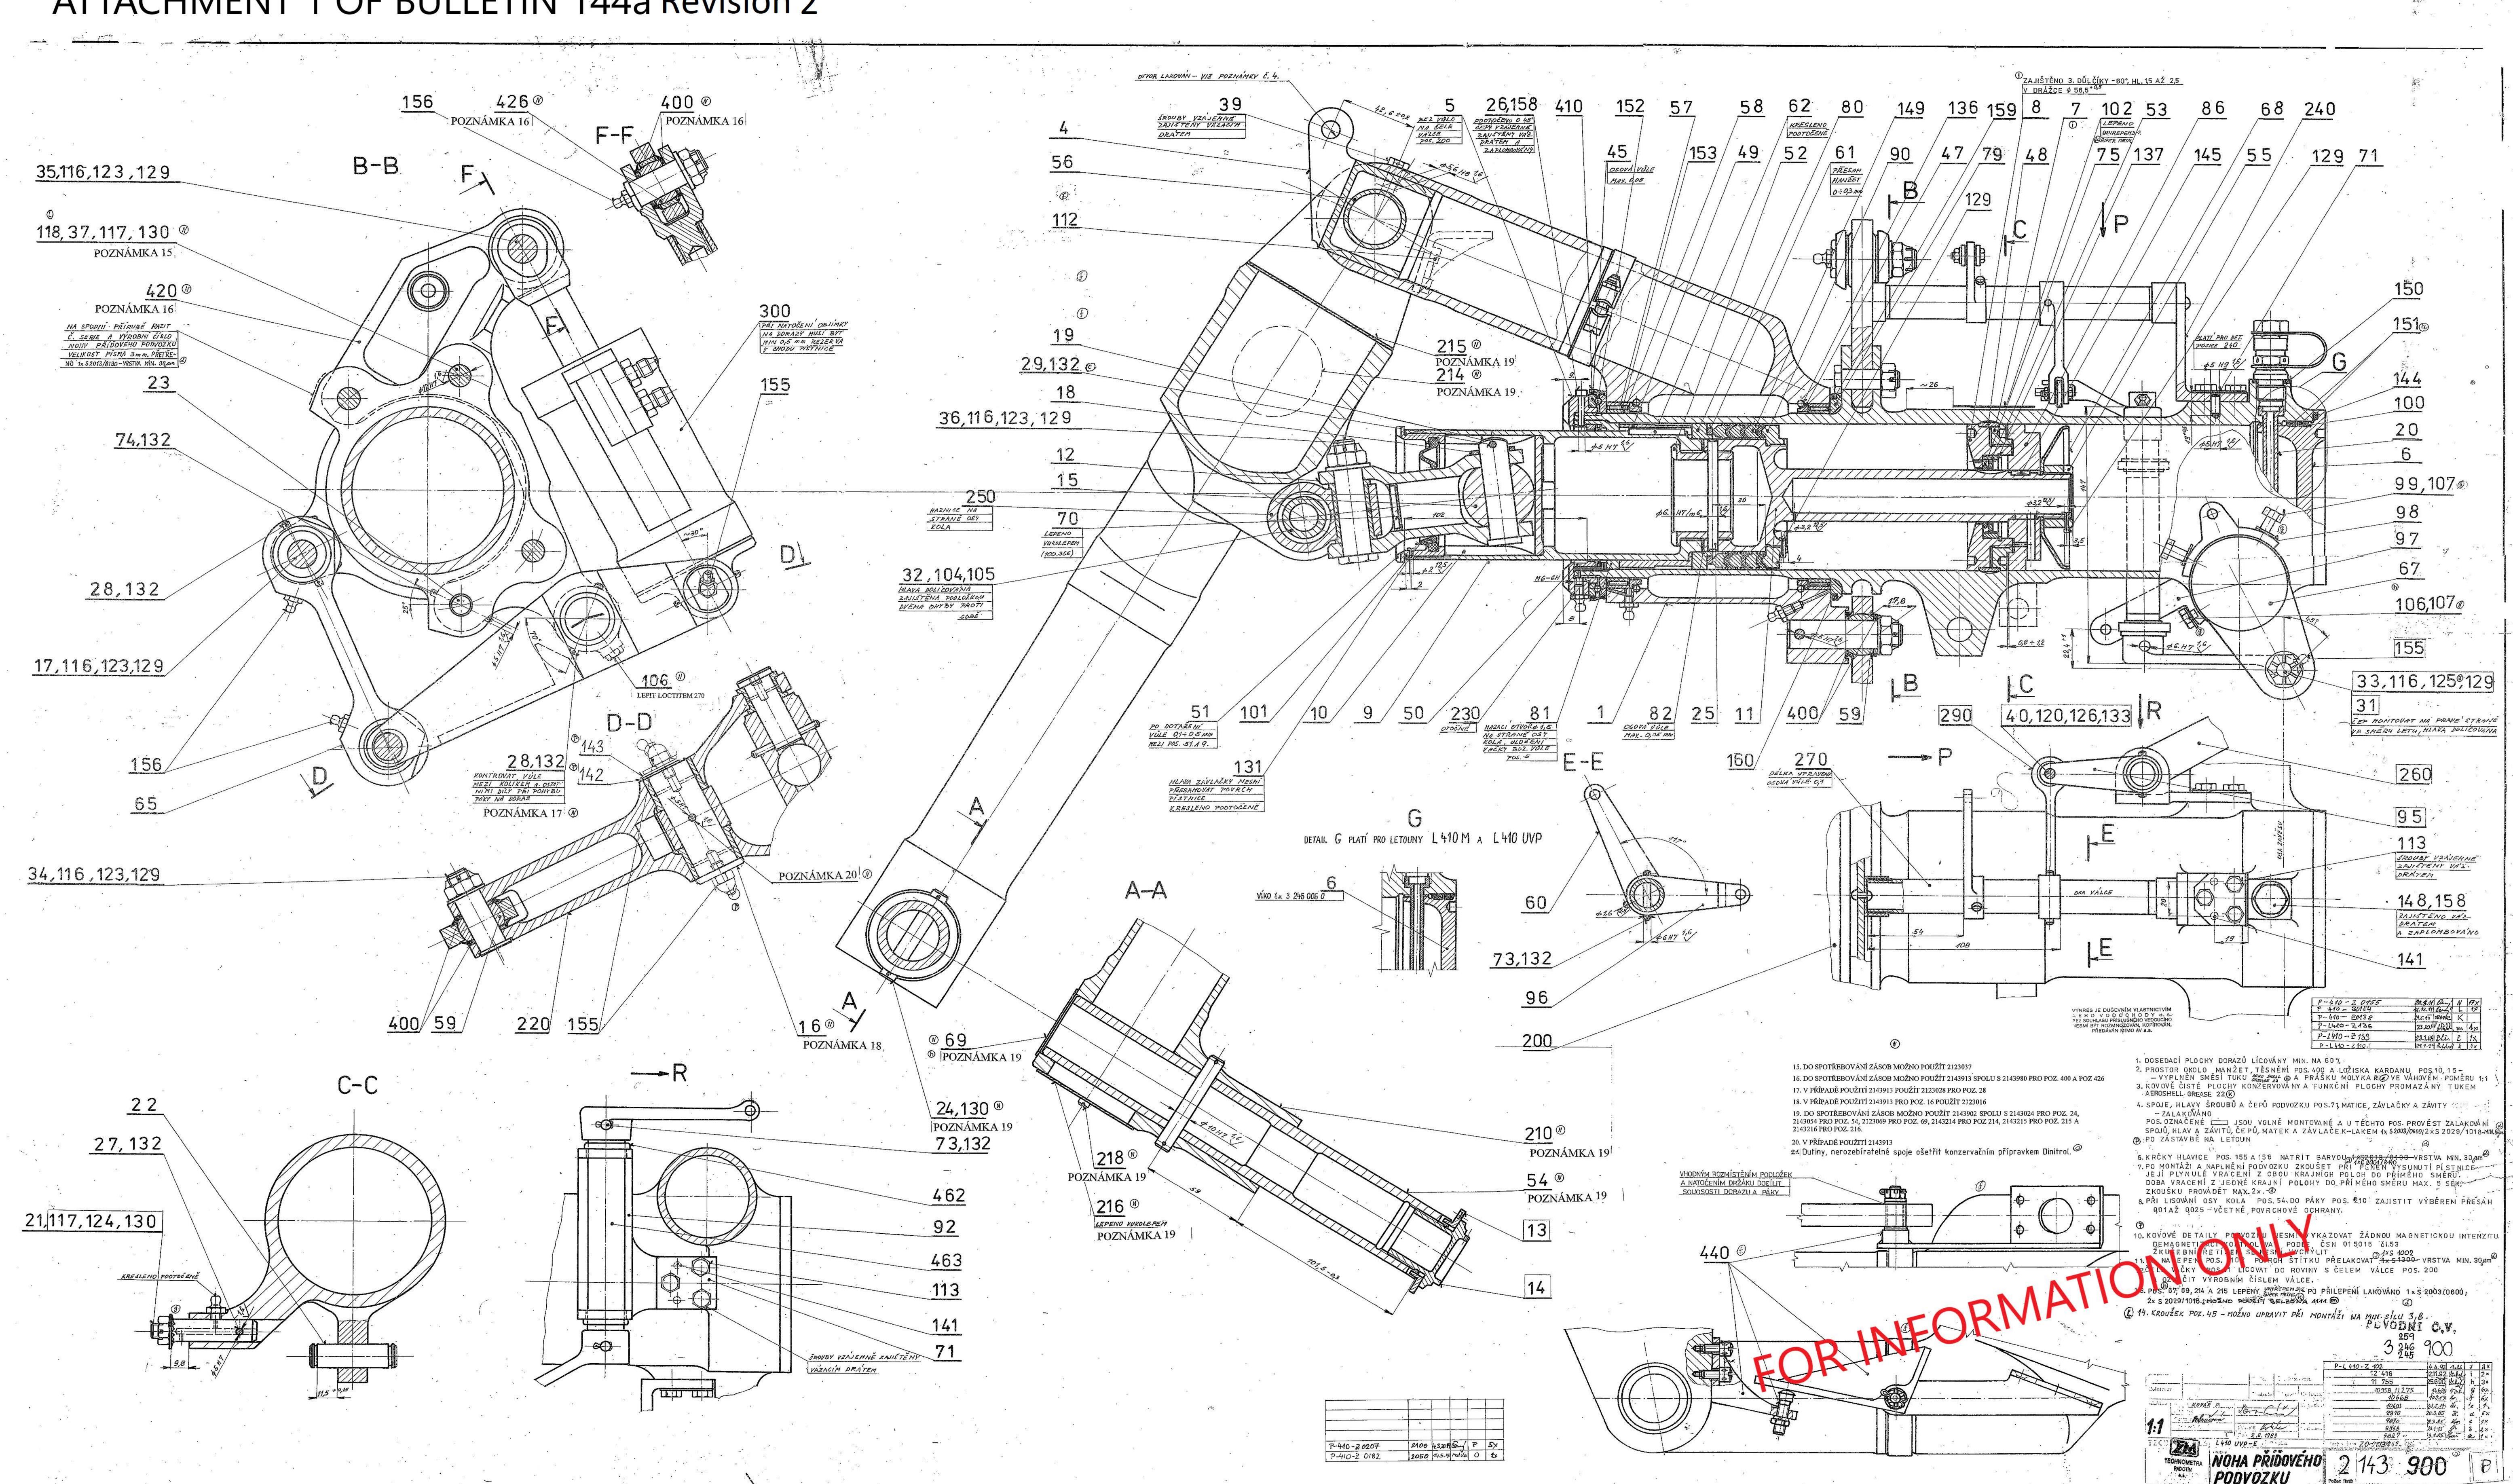
2 143 900 Nose landing gear leg (see Attachment 1 of this bulletin)
