Aircraft Industries

MANDATORY BULLETIN

SB No.: L410UVP/197a Revision 1

Subject: Nose landing gear inspection and eventually replacement of the L3 223 016 pin with the new L3 223 316 pin of the lever assembly of the nose landing gear steering. Prescription the torque for installation of the retaining bolt.

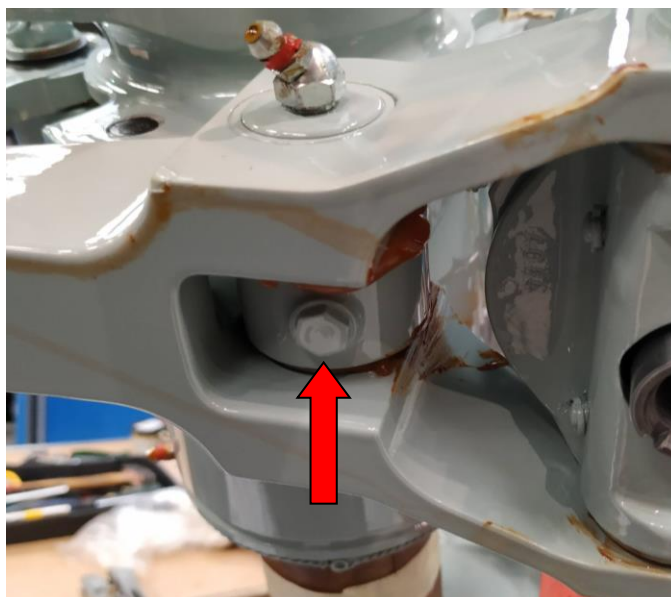
Figure 1 - L3 223 016 pin without head secured with a retaining bolt

If the L3 223 016 pin without head and secured with retaining bolt is installed (refer to the Figure 1), perform the L3 223 016 pin replacement according the point 2.B., C. of this bulletin.

- Remove the grease nipples.
- Heat the retaining bolt secured with Loctite 270 adhesive on the lever assembly see Figure 1 to 250°C with a hot air gun.
- Unscrew the retaining bolt.
- Remove the original pin pos. 16.

- Check the surface of the sliding bushes.
- Install the new pin pos. 16, put on washer pos. 142 and secure it with lock ring pos. 143 according to the Dwg. No. 2 143 900. Use material of point 3.A. of this bulletin
- Degrease the threads of the retaining bolt pos. 106 and pin pos. 16.
- Apply Loctite 270 on the retaining bolt thread, according to the technical sheet. Screw on the retaining bolt to the pin and tighten it, use torque 8 Nm!
- Install back the grease nipples.

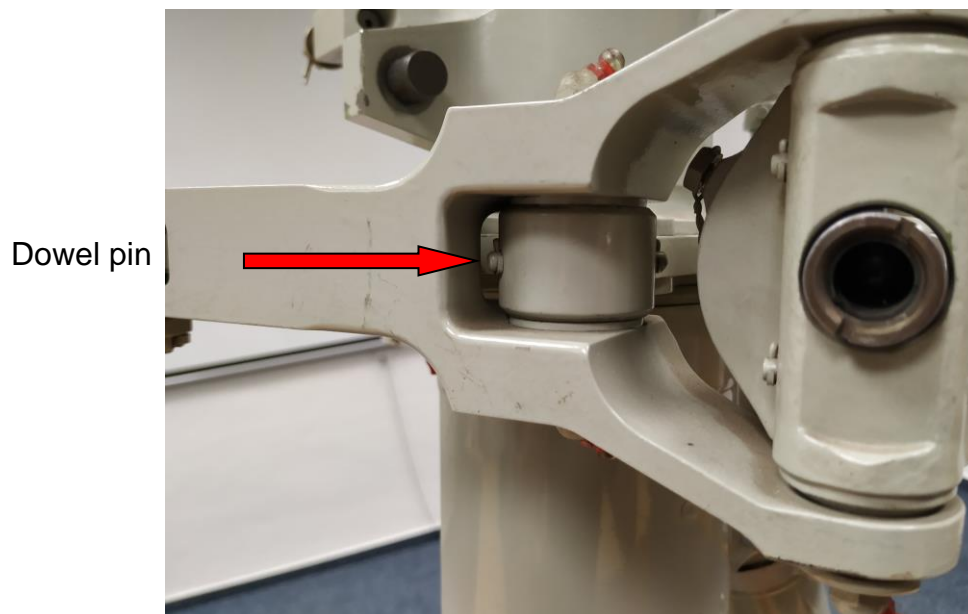
Figure 2 - L3 245 016 pin without head secured with a dowel pin

If the L3 245 016 pin without head and secured with dowel pin is installed (refer to the Figure 2), record the inspection of the nose landing gear into the log book according to the point 4.b) of this bulletin.
