Aircraft Industries

INFORMATION BULLETIN

IB No.: L410UVP-E/531b

Subject: Blanking of the drain holes.

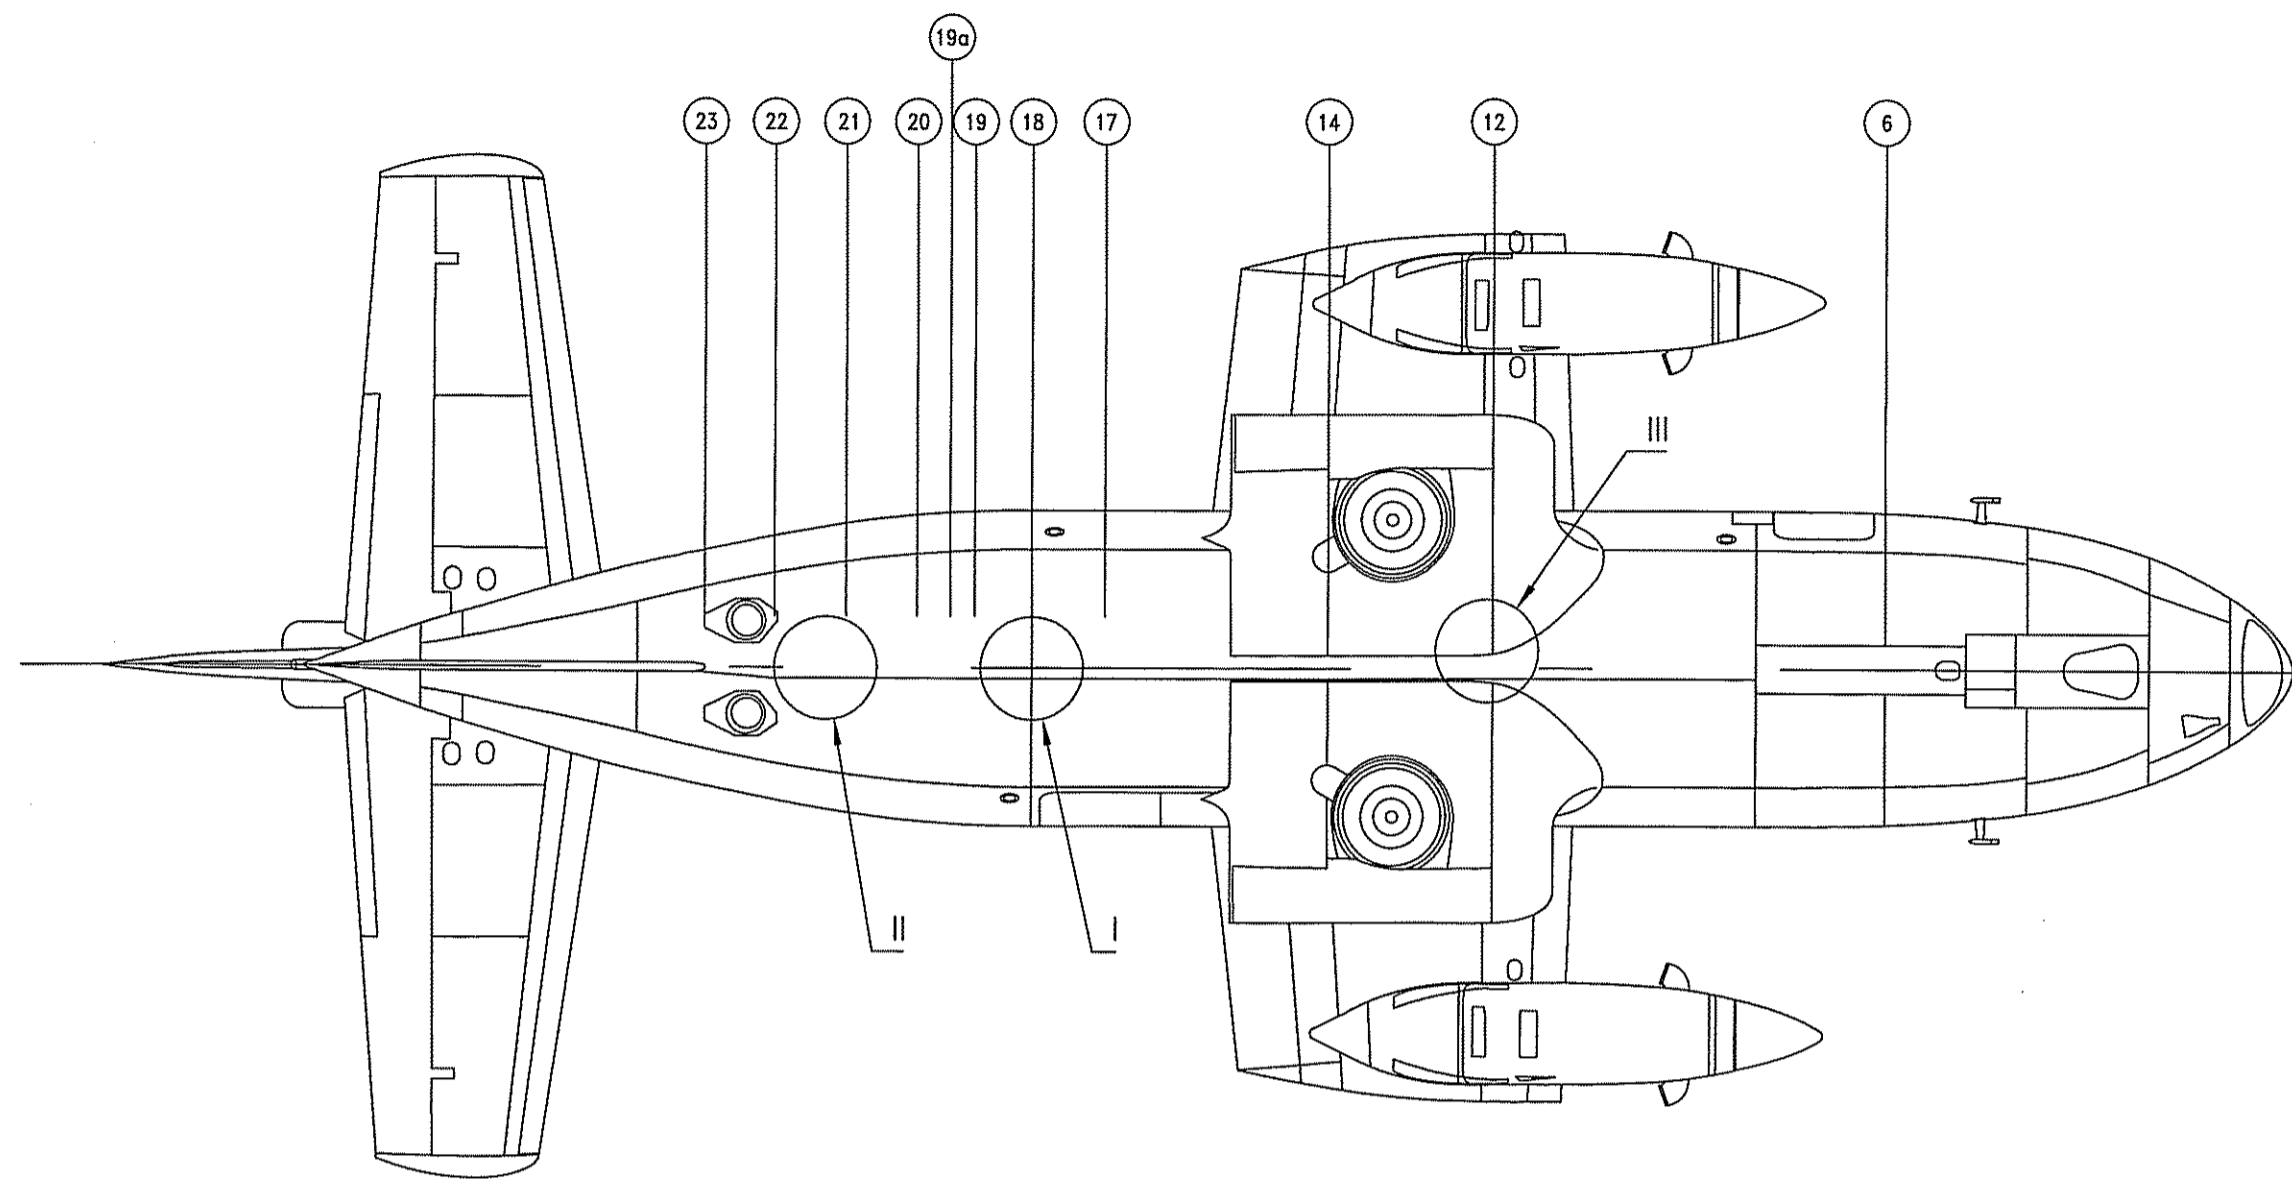
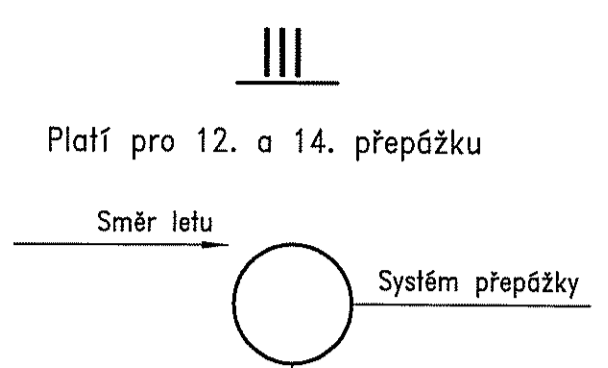
I
Typické pro 18. přepážku

Dle potřeby překryjte odvodňovací otvor pozicí 1.

- Install blinders for the drain holes according to the Dwg. No. B520 234N, according to operators requirements. It is recommended to install blinders at least on 18th frame and behind it.
