Aircraft Industries, a.s.

MANDATORY BULLETIN

MB No. : L13 / 105 a

Concerning: All L13 , L13A BLANÍK gliders

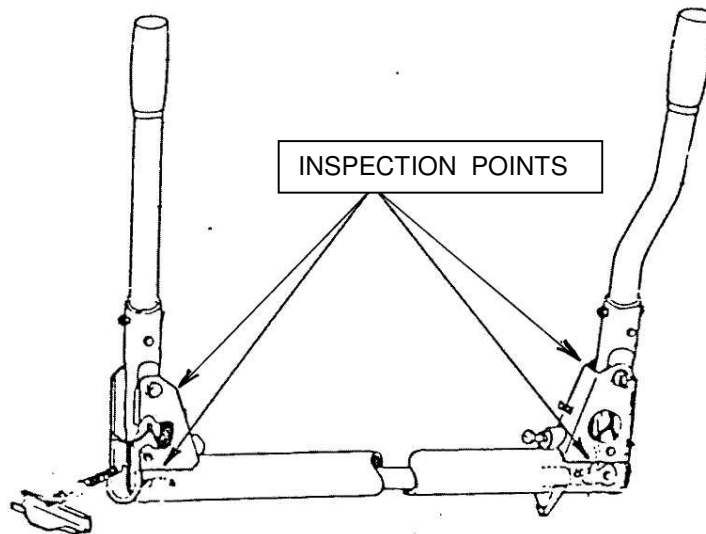
Pic.No. 1

1. Dismantle the covers of both front and rear lever .
2. Inspect visually by means of 6x magnifying magnifier the bedding of front and rear control lever on the control bridge Dwg. No. A401 001N (old Dwg. No. L13.401-Z1) or Dwg. No. A740 370N, according to the specified design of sailplane, at the places around welds and bends (according to pic.1 on both sides of the bridge) for presence of cracks .
Lighten up inspected the places properly. For visually inspection deflect gradually the control lever to the right side endstop (minimum aileron deflection) and still press on the control lever handle to the right with moderate pressure 40 ± 10 N up to the endstop - inspect the relevant part of the bridge, at which springing it causes sharpening of eventual cracks. By the same method carry out inspection at left deflection of control lever. Crack incidence is not allowed .
Carry out checks at designated places of the control bridge at control levers in front and rear cockpit.

5. In a case that some cracks in a bedding have been found, it is necessary to carry out replacement of defected control bridge for a new one according to the Drg. No. A740 370 N design before continuing operation. For L13 glider there is also installation of original control bridge Dwg. No. A401 001N allowed, provided operator or servicing centre has original Bedding Dwg.No. A741 215N (old Dwg.No. L13.401-25.P1) as unused spare part at disposal.
Carry out replacement according to the Technical and Maintenance Manual of the L13 sailplane / Edition No.4 from the year 1978 or according to the Operational and Maintenance Manual of L13 sailplane - without overhauls or according to the Operational and Maintenance Manual of L13A sailplane, depending on which Manual is actual for given sailplane.
Inform immediately manufacturer about found defect at the same time with handover of sailplane operation data with a view to aerial acrobatics rate.
