MANDATORY BULLETIN

MB No.: L23/048a

Concerning: All L-23 SUPER-BLANÍK gliders up to S/N 039019

Reason: Check of the elevator rocker lever for possible cracks finding

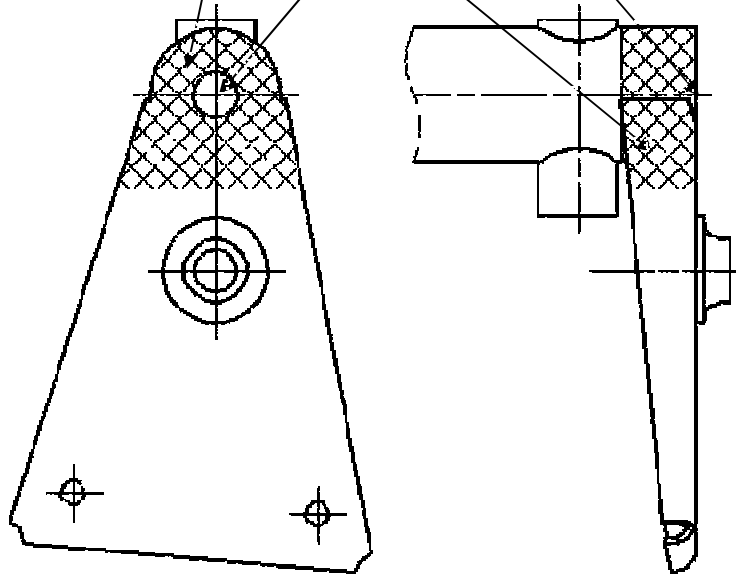
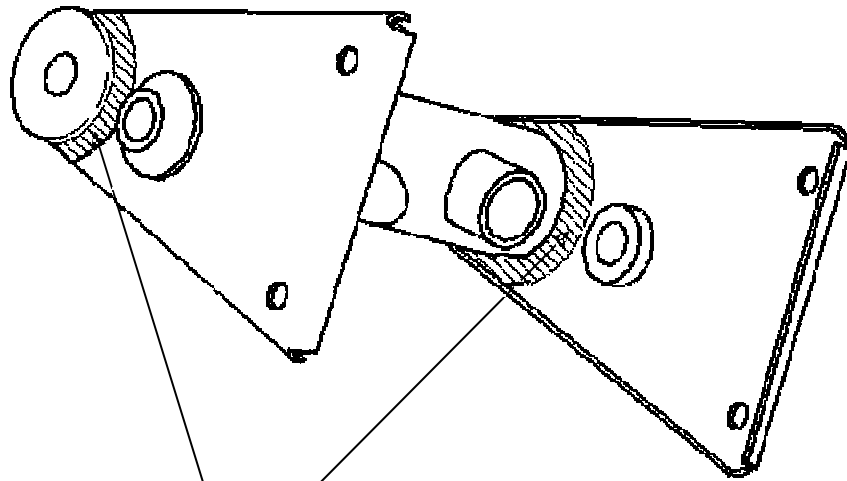
Fig. 1

Checked area: Whole circuit of welds connecting the side arms with connecting rod and the welds adjacent area of width of 5 mm.

Criteria of acceptance: Cracks in the checked area of the part are not acceptable.

Fig. 1: Area of painting removal and checked area of the part.

OBLAST ODSTRANĚNÍ NÁTĚRU
PAINTING REMOVAL AREA

OTVORY NA OBOU KONCÍCH TRUBKY CHRÁNIT
PŘED ZATEČENÍM ODSTRAŇOVAČE NÁTĚRU
PROTECT OPENINGS ON BOTH ENDS OF THE ROD
AGAINST PENETRATION OF PAINT REMOVER

KONTROLOVANÁ OBLAST :
SVARY SPOJUJÍCÍ BOČNICE A TRUBKU A
PŘÍLEHLÁ OBLAST SVARU O ŠÍŘCE 5 mm
CHECKED AREA :
WELDS CONNECTING THE SIDE ARMS
WITH THE ROD AND WELD ADJACENT
AREA OF WIDTH OF 5 mm

- Follow the recommendation of paint remover manufacturer.
- Protect the openings on both ends of the rod before the penetration of the paint remover (see fig. 1).
- Lay the part on a proper layer, for example on polyethylene foil.
- In the area of paint removal according to fig. 1, by a proper way, for example with a brush, apply on both sides of the rocker lever the paint remover containing chlorinated hydrocarbons (for example P 8201-Ligin).
- Wait till the painting lifts.
- Remove the rest of painting and the paint remover with help of plastic stopper which does not damage the surface of the part.
- If the painting is not removed totally, repeat the procedure.
- Clean the part with help of nitro-solvent (for example C 6000) and cotton rubber.

Perform the check by the non-destructive testing - magnetic testing (NDT MT). The used method has to comply with requirements of ASTM E 1444 - Standard procedure for testing by magnetic particles, or MIL-STD-1949, E 709. The test parameters depend on the used equipment.

Warning: In case of cracks finding in the checked area the checked part is not acceptable for next operation. Send this part together with the Record about the test to the manufacturer who will send you a spare part. The Record has to contain the information about the position and size of cracks, S/N of the glider and TSN (flight), and cycles since new.
