MANDATORY BULLETIN

MB No. : L23 / 050a REVISION No. 2

Concerning: All L23 Super-Blanik sailplane .

Reason: Check of the control bridge at the place of gripping of control levers in the front and rear cockpit to exclude presence of eventual cracks .

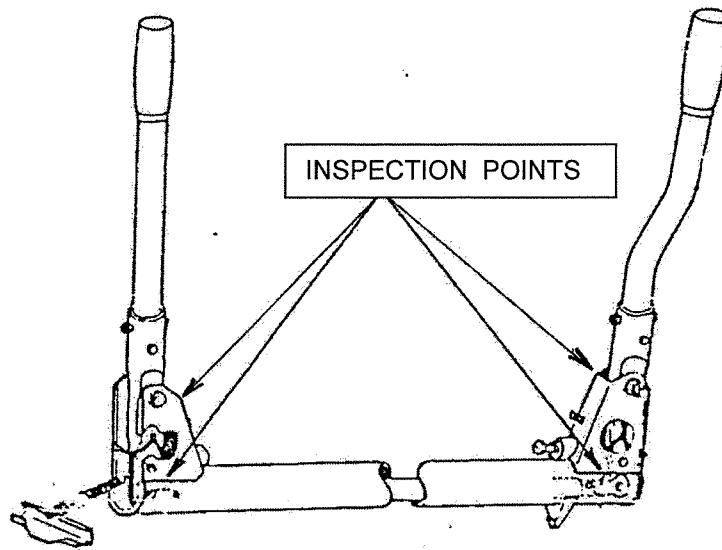
Pic.No. 1

1. Dismantle the covers of both front and rear lever .
2. Inspect visually by means of 6x zoom magnifier the bedding of front and rear control lever on the control bridge Dwg. No. A740 370N (or old design A741 210N – if installed) at the places around welds and bends (according to pic.1 on both sides of the bridge) for presence of cracks .
Lighten up inspected the places properly. For visually inspection deflect gradually the control lever to the right side endstop (minimum aileron deflection) and still press on the control lever handle to the right with moderate pressure 40 ± 10 N up to the endstop - inspect the relevant part of the bridge, at which springing it causes sharpening of eventual cracks. By the same method carry out inspection at left deflection of control lever. Crack incidence is not allowed . Carry out checks at designated places of the control bridge at control levers in front and rear cockpit.

5. In a case that some cracks in a bedding have been found, it is necessary to carry out replacement of defected bedding Dwg.No. A740 371N in control bridge assembly Dwg. No. A740 370 N before continuing sailplane operation.
Carry out replacement according to the Maintenance Manual L23 SUPER-BLANIK . Before replacement remove 2 pcs of bearings from the original Bearing A740371N according to the procedure in Apendix No.1. of the bulletin and install them into the new bedding, provided they are in a good condition.
