# SERVICE BULLETIN

SB No. **L-410/110b**

Aeroplane Type: **L-410**

**Subject:** Inspection of the wing flaps and slats for cracks.

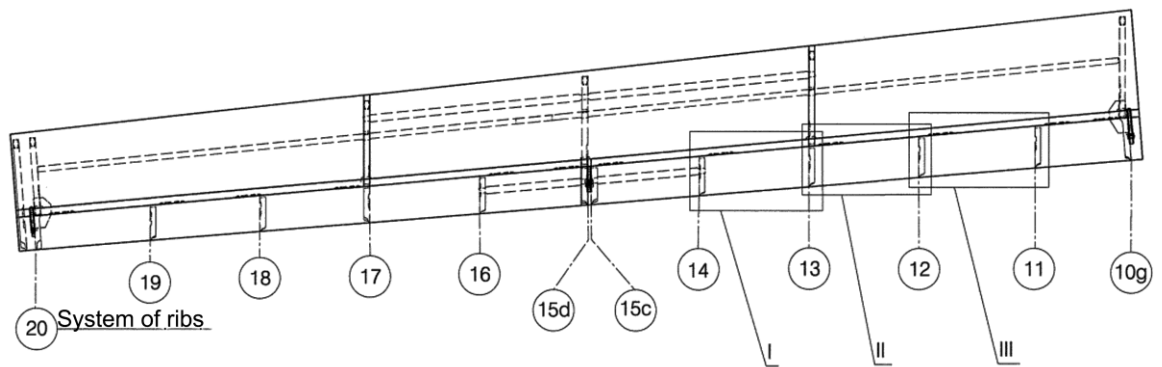
Fig. 1 Outboard wing flap bottom side

Possible occurrence of cracks on the bottom side of wing flaps and slats at the rivets area along the front spar.

Inspect visually skin of the LH and RH wing flaps bottom side along the front spar in the rivets areas No. I, II, III, IV, V, VI, VII marked in the Figures 1 and 2.

Repair the wing flap/s and/or slat/s in accordance with the ARM, sec. 57-00-00, page 424 if the number or length of cracks specified in the MM, sec. 057.50.00, Fig. 303 are exceeded on the L 410 UVP-E20 aeroplanes.

Contact Aircraft Industries, a.s. if the number or length of cracks specified in the MM, sec. 57-50-00, point 4.E.(3), page 304 are exceeded on the L 410 NG aeroplanes.

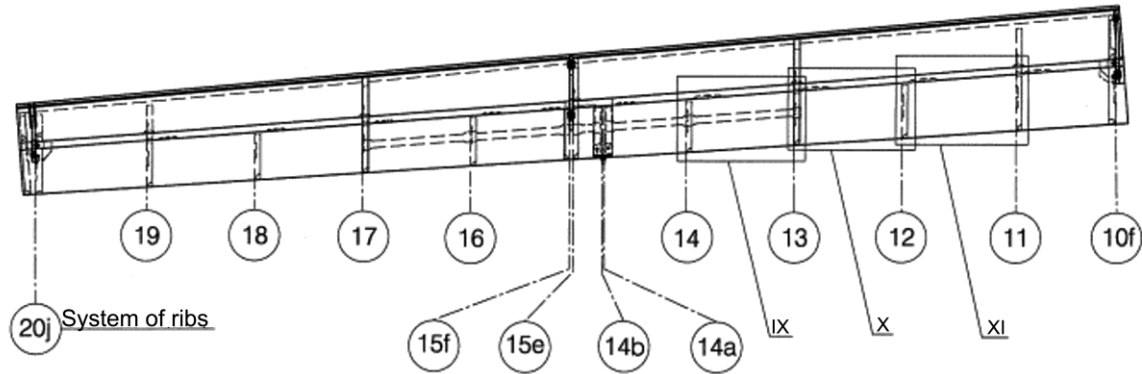
Fig. 3 Outboard slat bottom side

Inspect visually skin of the LH and RH slats bottom side along the spar in the rivets areas No. IX, X, XI, XII, XIII, XIV, XV marked in the Figures 3 and 4.
