# SERVICE BULLETIN

SB No. **L-410/163b**

Aeroplane Type: **L-410**

**Subject:** Check and possible replacement of the B535 406N clamps of autopilot rudder servo actuator cables.

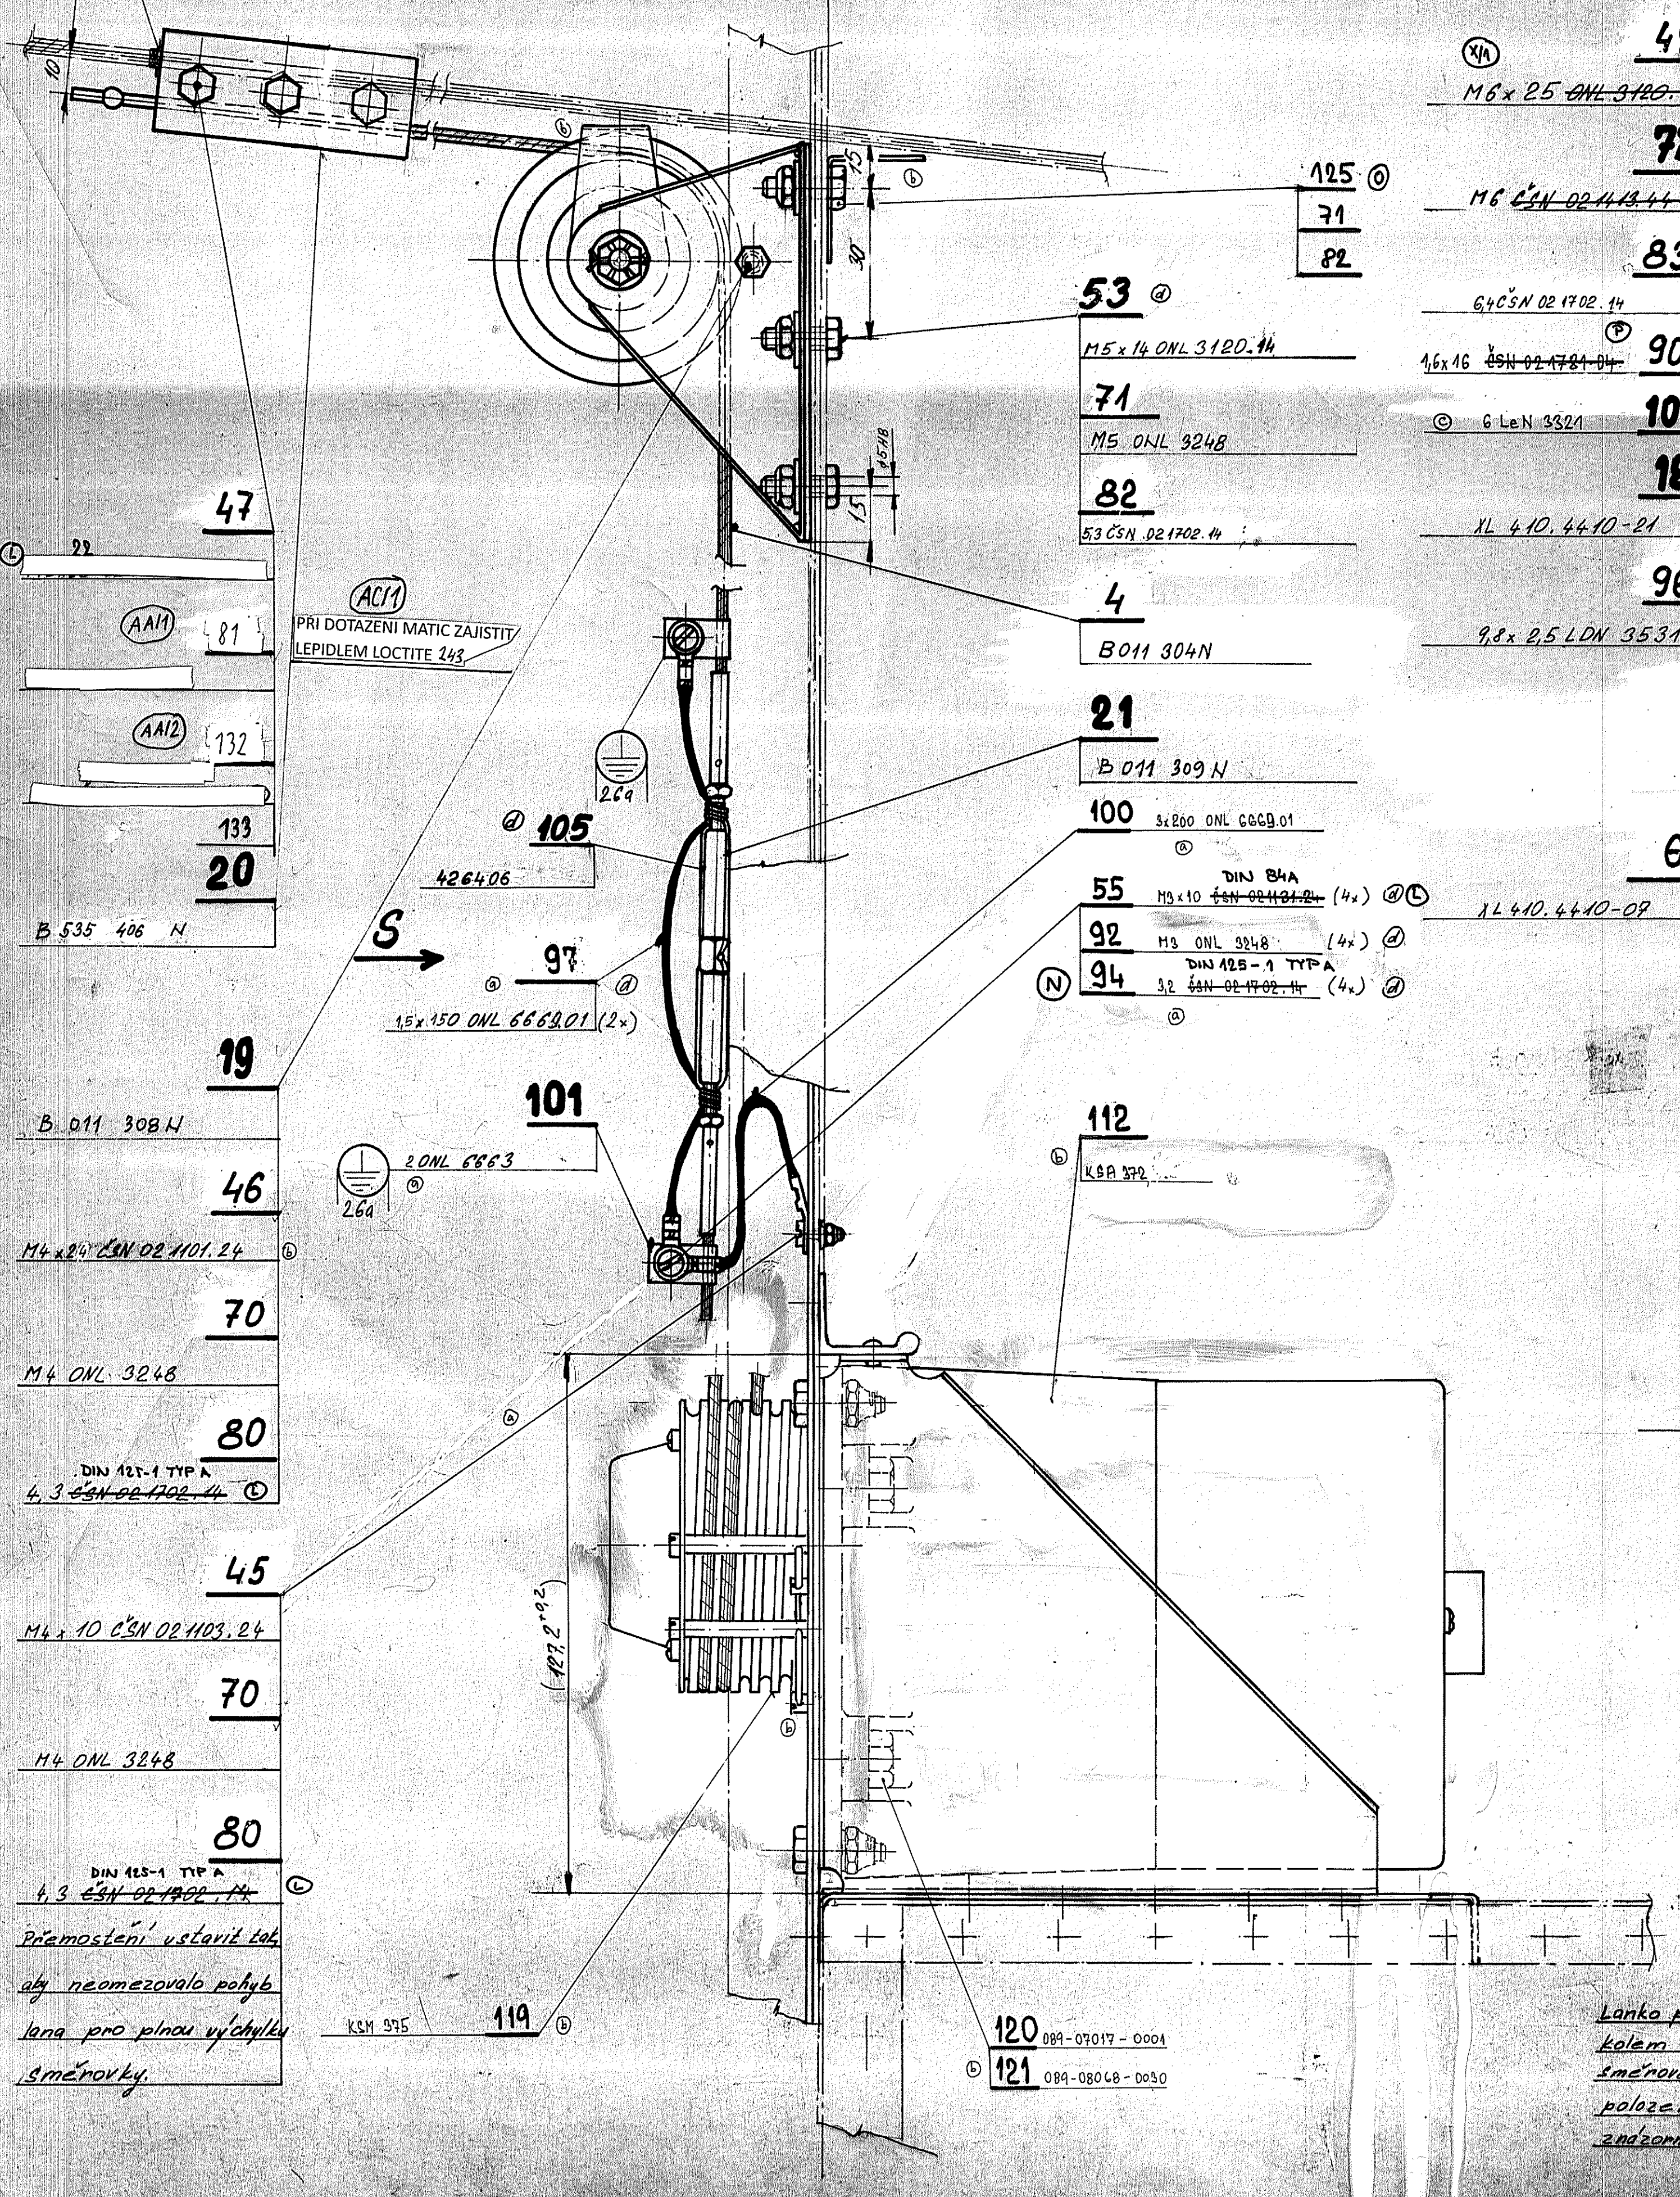
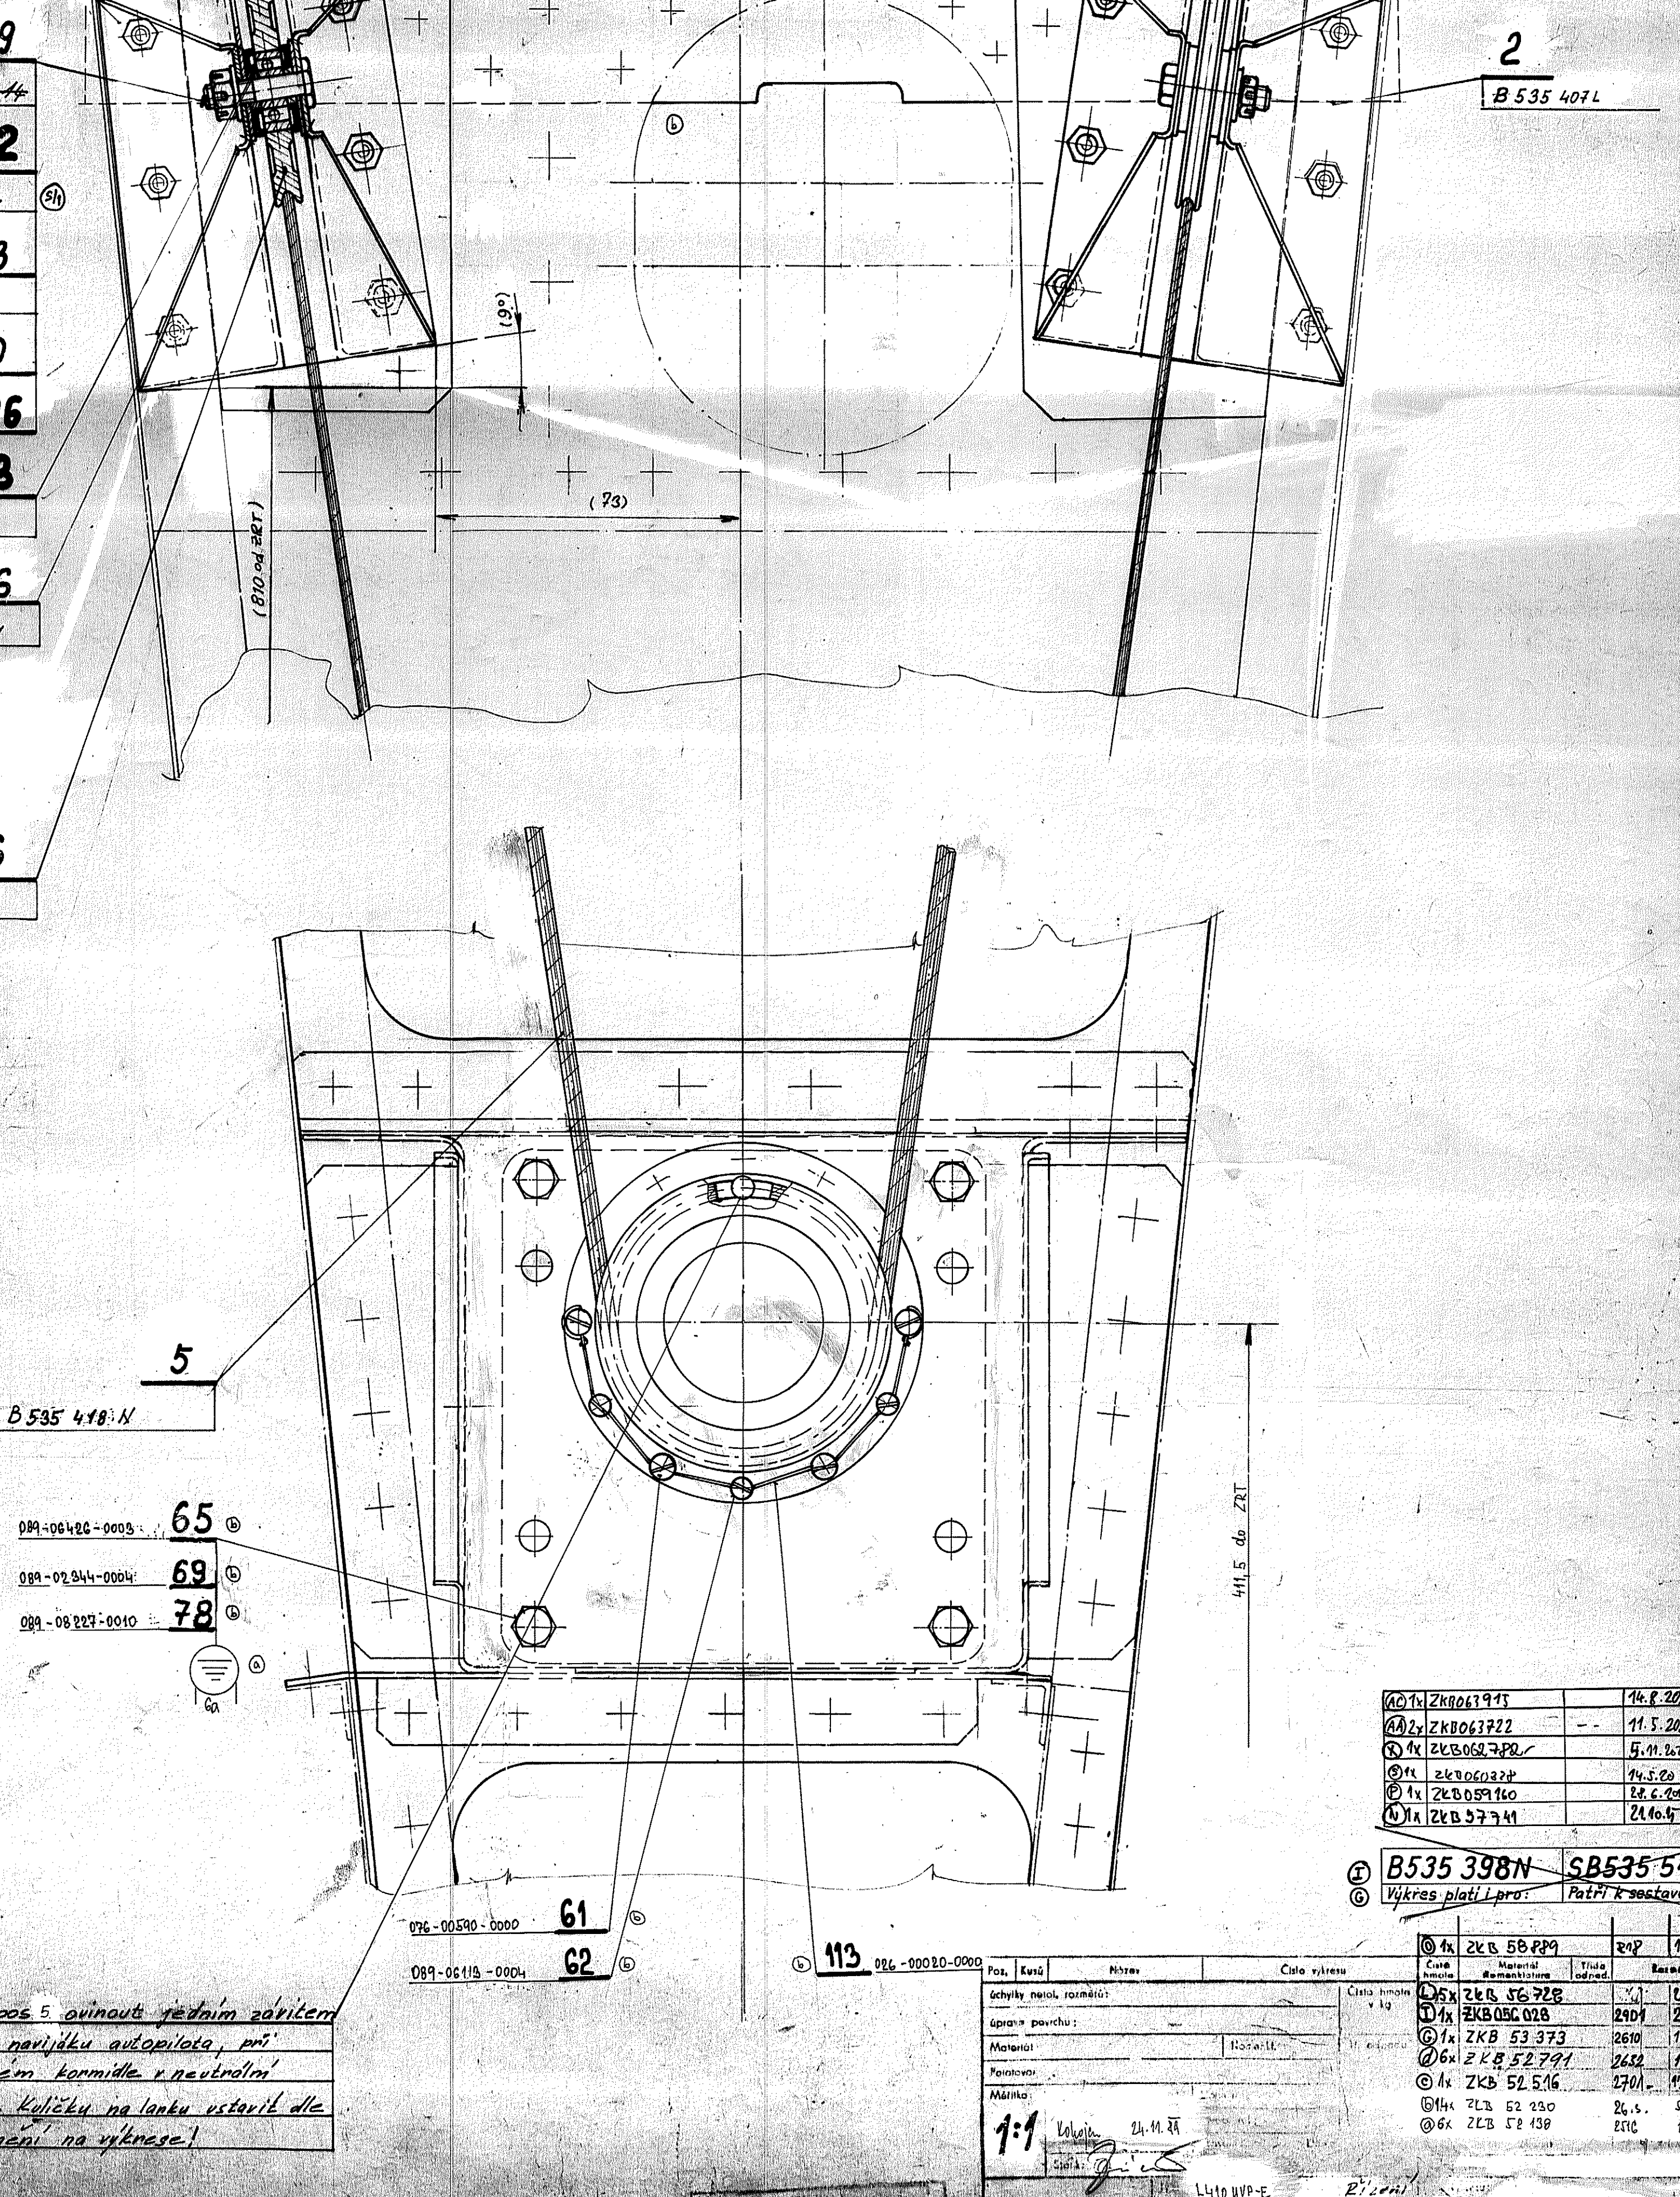
# Detail VI<sub>6</sub>

Shift the B535 406N clamp due to a combination of several factors.

- Check that the clamps pos. 20, Dwg No. B535 401N sheet 6, Detail VI6 on the rudder control cables have not shifted by means of the red marking.
  - If the clamps have not shifted, make a record in the Aeroplane Logbook according to the point 4. of this bulletin.
  - If any of the clamps has shifted, replace both original clamps by new ones together with fasteners according to the points 2.C., 2.D. of this bulletin.

zařít barvou C 2001/B140  
(pro kontrolu posunutí, vorty po lank)

- Cut and remove locking wires and loosen the turnbuckles pos. 21, Dwg No. B535 401N sheet 6, Detail VI6.
- Unscrew the original nuts pos. 132, remove washers pos. 81, pull out screws pos. 47 and remove original clamps pos. 20.

- Carefully degrease the rudder control cables with benzine at location of the clamps pos. 20, Dwg No. B535 401N sheet 6, Detail VI6.
- Install new clamps pos. 20 (appropriate groove radius must be set on approp. diameter of a cable) by means of new fasteners pos. 47, 81, 132 and torque the nuts to 5 - 6 Nm. A gap between halves of a clamp must be at least 0.8 mm. Secure the nuts with Loctite 243 according to the MM, sect. 020.20.00, page 845. Use material pos. 1 to 4 of point 3.A. of this bulletin and pos. 1 of point 3.B.

- Adjust the cable tension by means of the turnbuckles pos. 21 according to the MM, sect. 022.10.00, point 1.E.(15), page 408, table 401 (or point 1.E.(8), page 406, table 402 for L-420). **The thread of the cable end must be hidden in the turnbuckle by at least 8 mm!**

- Secure the turnbuckles pos. 21 and fix the bonding with locking wire. Use material pos. 5 of point 3.A. of this bulletin.
